## Attack of the Clones

**Recognize this?** This is a discreet insulation displacement connector (IDC) manufactured by 3M. Or is it? It could be a clone manufactured in Asia. Knock-off connectors started showing up in the telephone industry many years ago. I'm sure that 3M is just one of many victims of knock-offs, and not just from Asia but anywhere in the world where they can make products for less and market them effectively. While some knock-offs are good quality, many aren't.

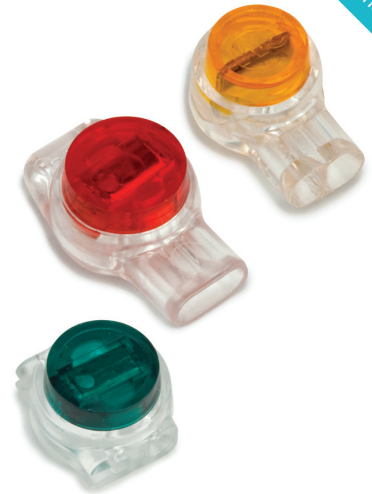
**Recognize this?** This is a discreet insulation displacement connector (IDC) manufactured by 3M. Or is it? It could be a clone manufactured in Asia. Knock-off connectors started showing up in the telephone industry many years ago. I'm sure that 3M is just one of many victims of knock-offs, and not just from Asia but anywhere in the world where they can make products for less and market them effectively. While some knock-offs are good quality, many aren't.

Let me give you some info on ways to determine if you are looking at a clone or looking at the real thing. And in some cases it isn't easy. Look for the supplier logo and make sure it's the right supplier logo. If you are in any doubt about the quality and maybe even the origin of discreet connectors in your network, call your local vendor's representative sales contact. These folks are trained to help you, and they love helping solve a problem that wasn't created by their product in the first place!
